SC59-001

Strut Cap Washer/Bush

SC59-001 STRUT CAP ASSEMBLY

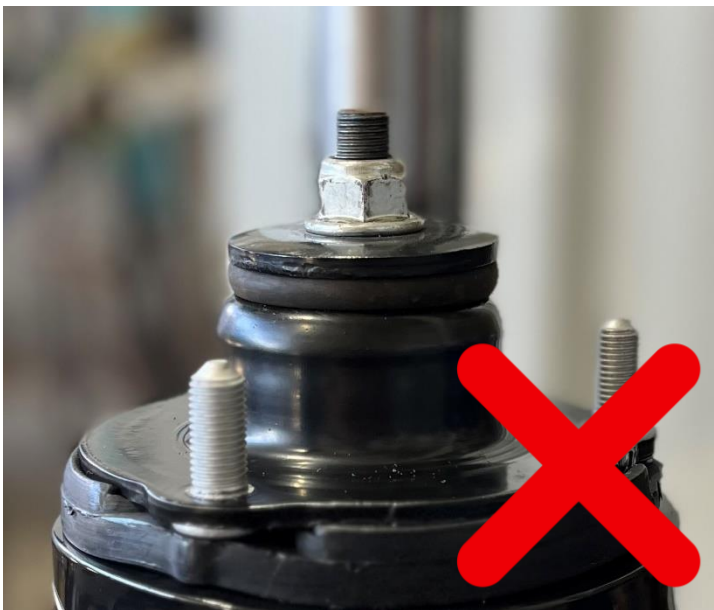
Not enough thread showing. The top bush may appear tight as there is force against it from the coil spring, however the bottom bush will still be loose.

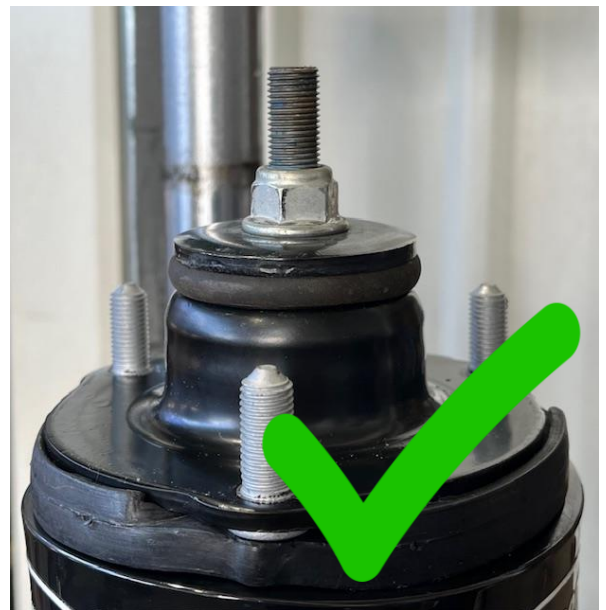
The top bush and the bottom bush is tight now.

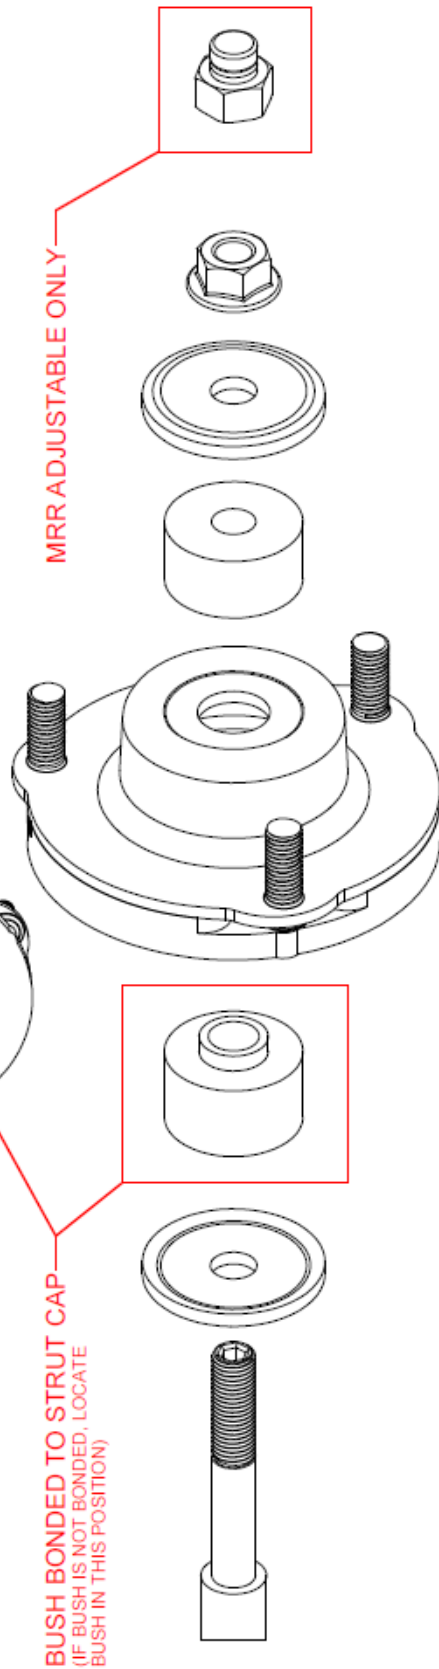
BUSH BONDED TO STRUT CAP
(IF BUSH IS NOT BONDED, LOCATE
BUSH IN THIS POSITION)

MRR ADJUSTABLE ONLY

1. Install as per order in diagram
2. The MRR Adjustable nut will go on last if the shock absorber is an MRR adjustable shock absorber.
3. Make sure the strut cap is aligned as per OEM shock absorber to fit back into the vehicle. For alignment on the strut cap see diagram.

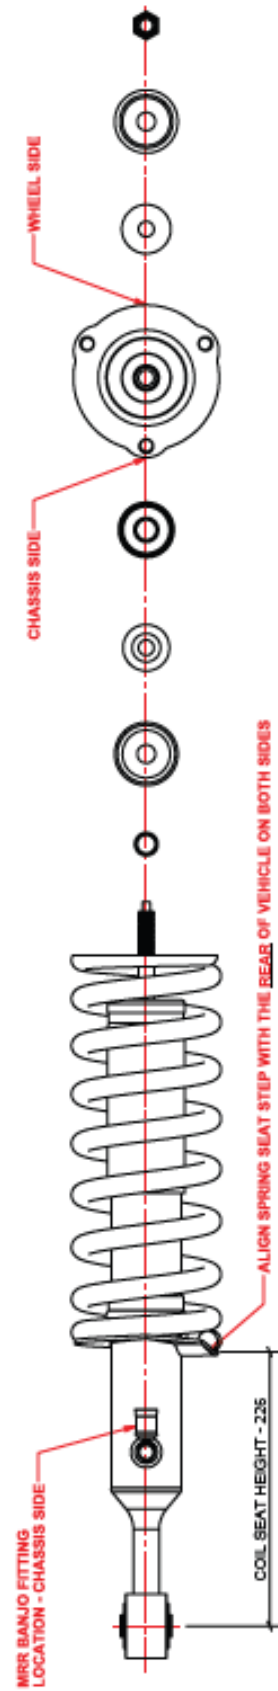
TOYOTA HILUX (2005-ON)
RIGHT HAND STRUT SHOWN

MRR BANK/O FITTING
LOCATION - CHASSIS SIDE

WHEEL SIDE

CHASSIS SIDE

ALIGN SPRING SEAT STEP WITH THE REAR OF VEHICLE ON BOTH SIDES

COIL SEAT HEIGHT - 225
